ENGINEERING REPORT
REHABILITATE VALLEY WATER SYSTEM
PACKAGE 249

YOSEMITE NATIONAL PARK

U.S. Department of the Interior
National Park Service
Denver Service Center

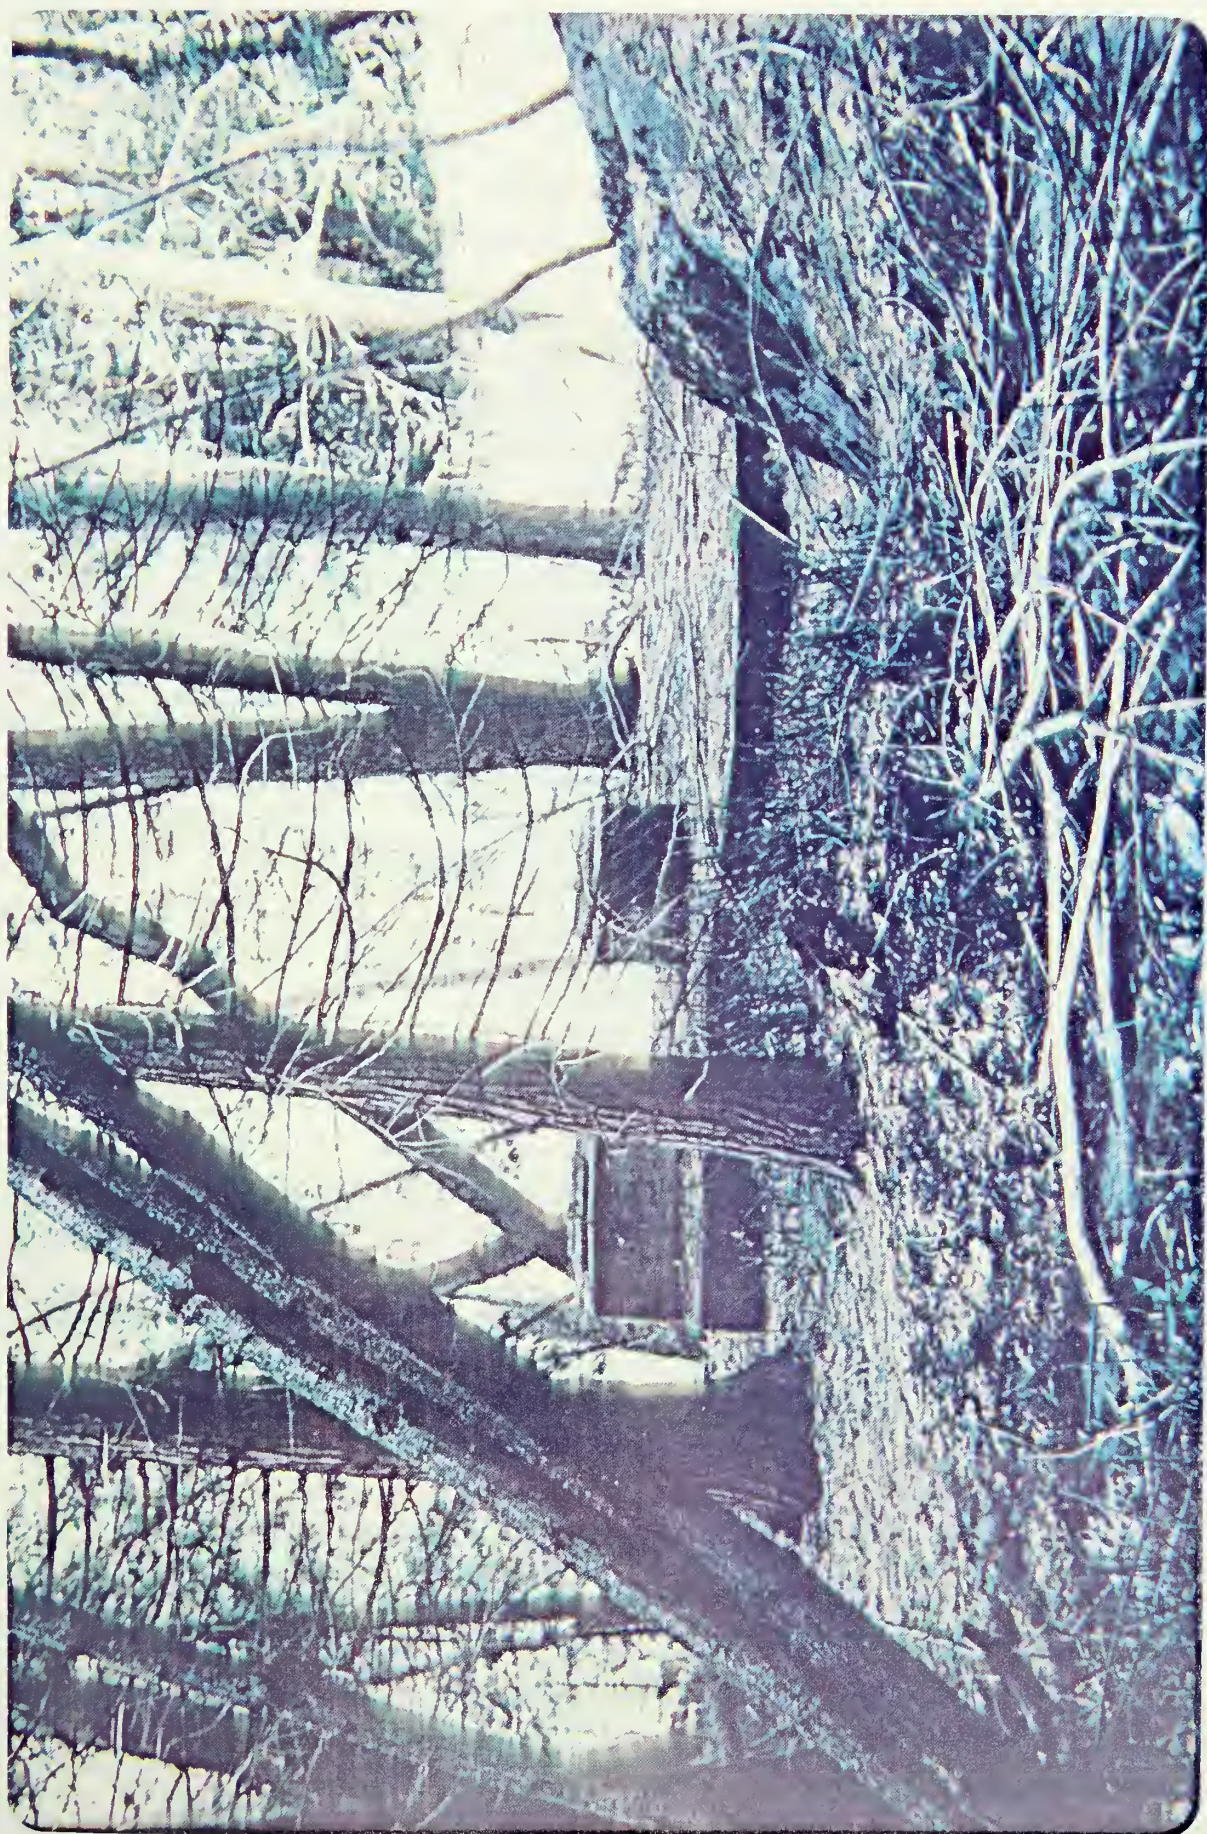
Abandoned Springs

The source of the springs is uncertain. Abandoned water lines from the river cross the area, and one of these old underground lines may be broken and the seepage is what is evidenced as springs. Or, the source of the water could be an exposed aquifer discharging its water on the surface. Whatever the source, the reliable flow has not been quantified. The flow fluctuates seasonally and the springs seem to be the principal water sources for a meadow immediately downslope.

The condition of the springs and collection systems seem to be adequate for possible reuse. Only minor rehabilitation, such as cleaning and patching, would be needed. The pumphouse is empty and should be torn down for safety reasons. The check valve and the distribution line to it from the springs were not inspected and their condition is unknown.

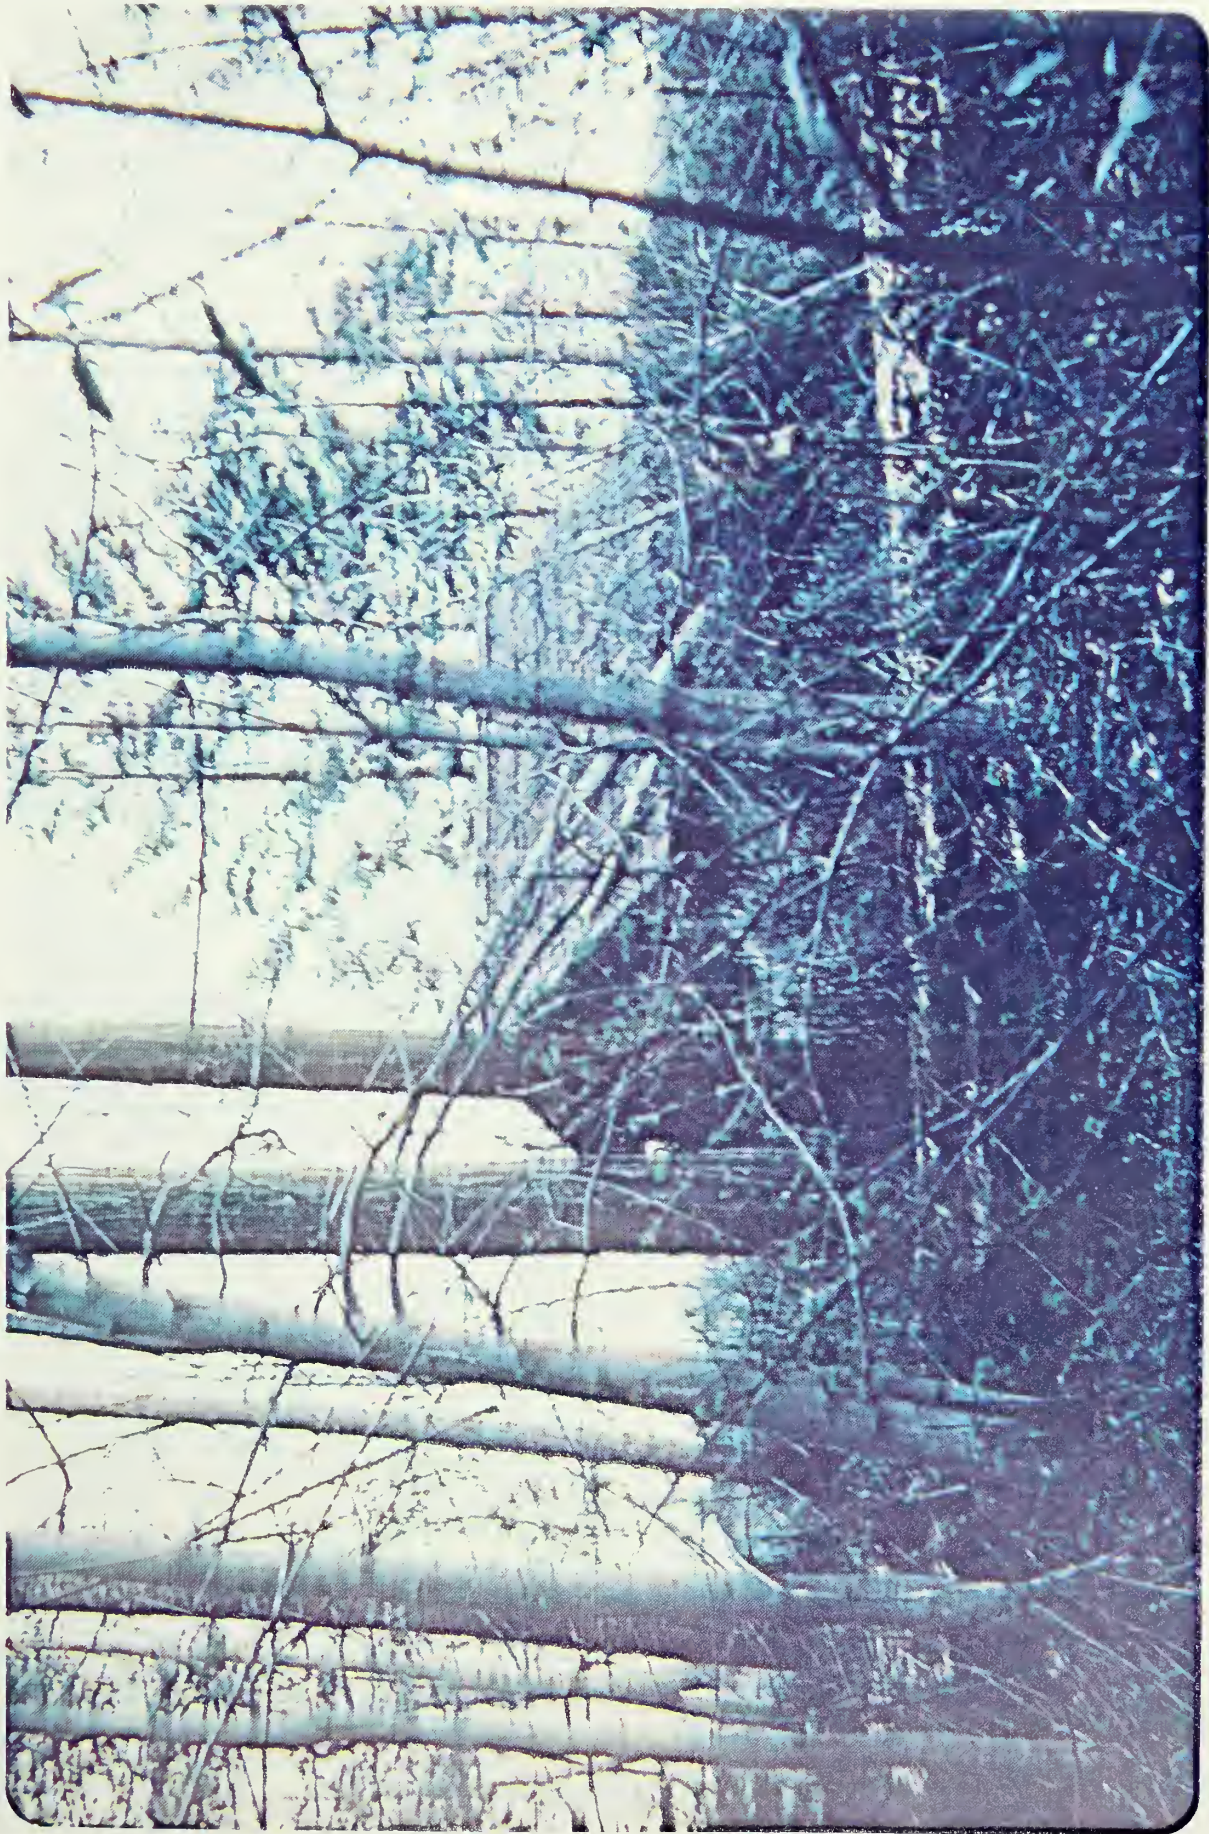
Abandoned Spring Pumphouse

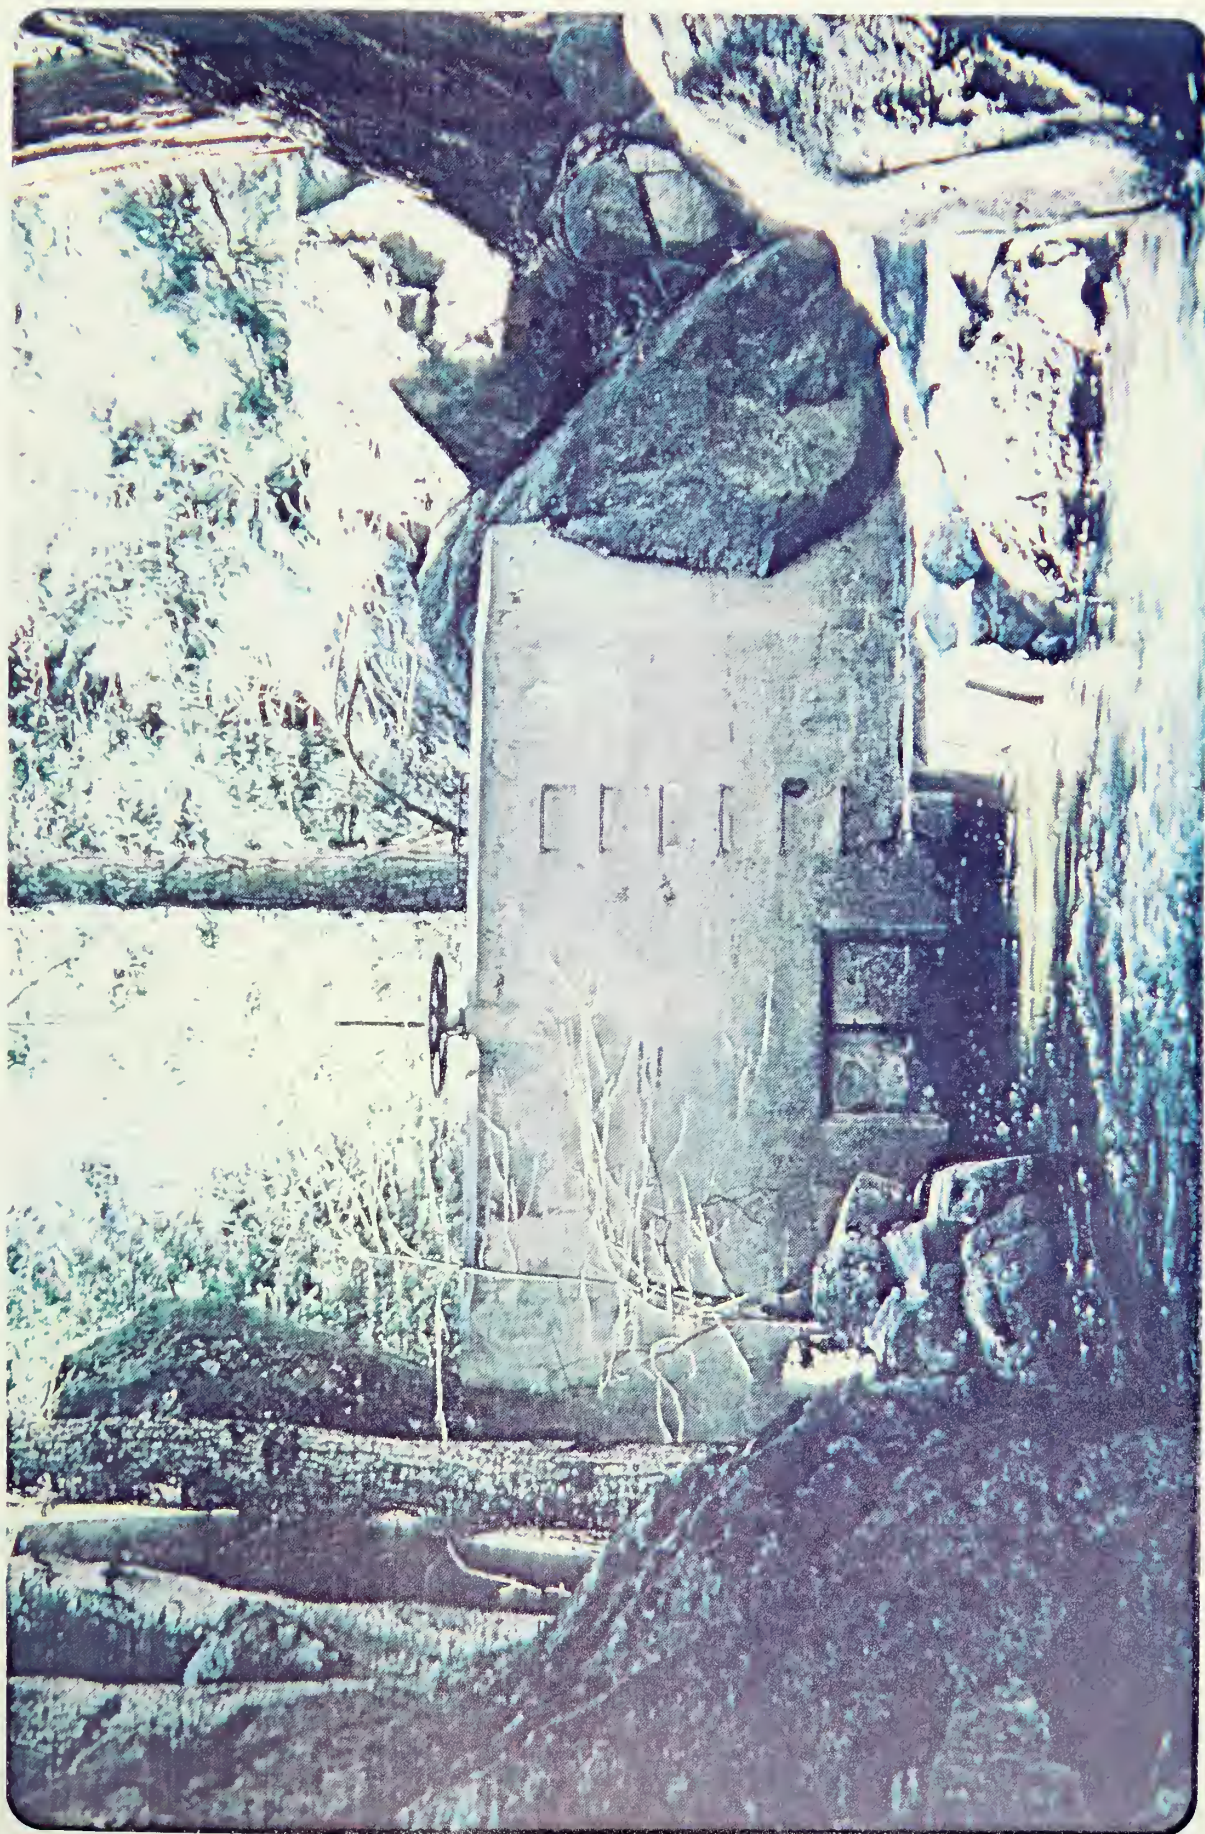
Water Intake Structure

The intake structure has been totally inundated during periods of extreme runoff, when the water level rises above the bar rack and renders it useless. During the spring runoff the water carries large amounts of silt and debris and the bar screen, which is not mechanically cleaned, has to be manually cleaned many times a day. A large portion of the concrete around the bar screen has deteriorated badly.

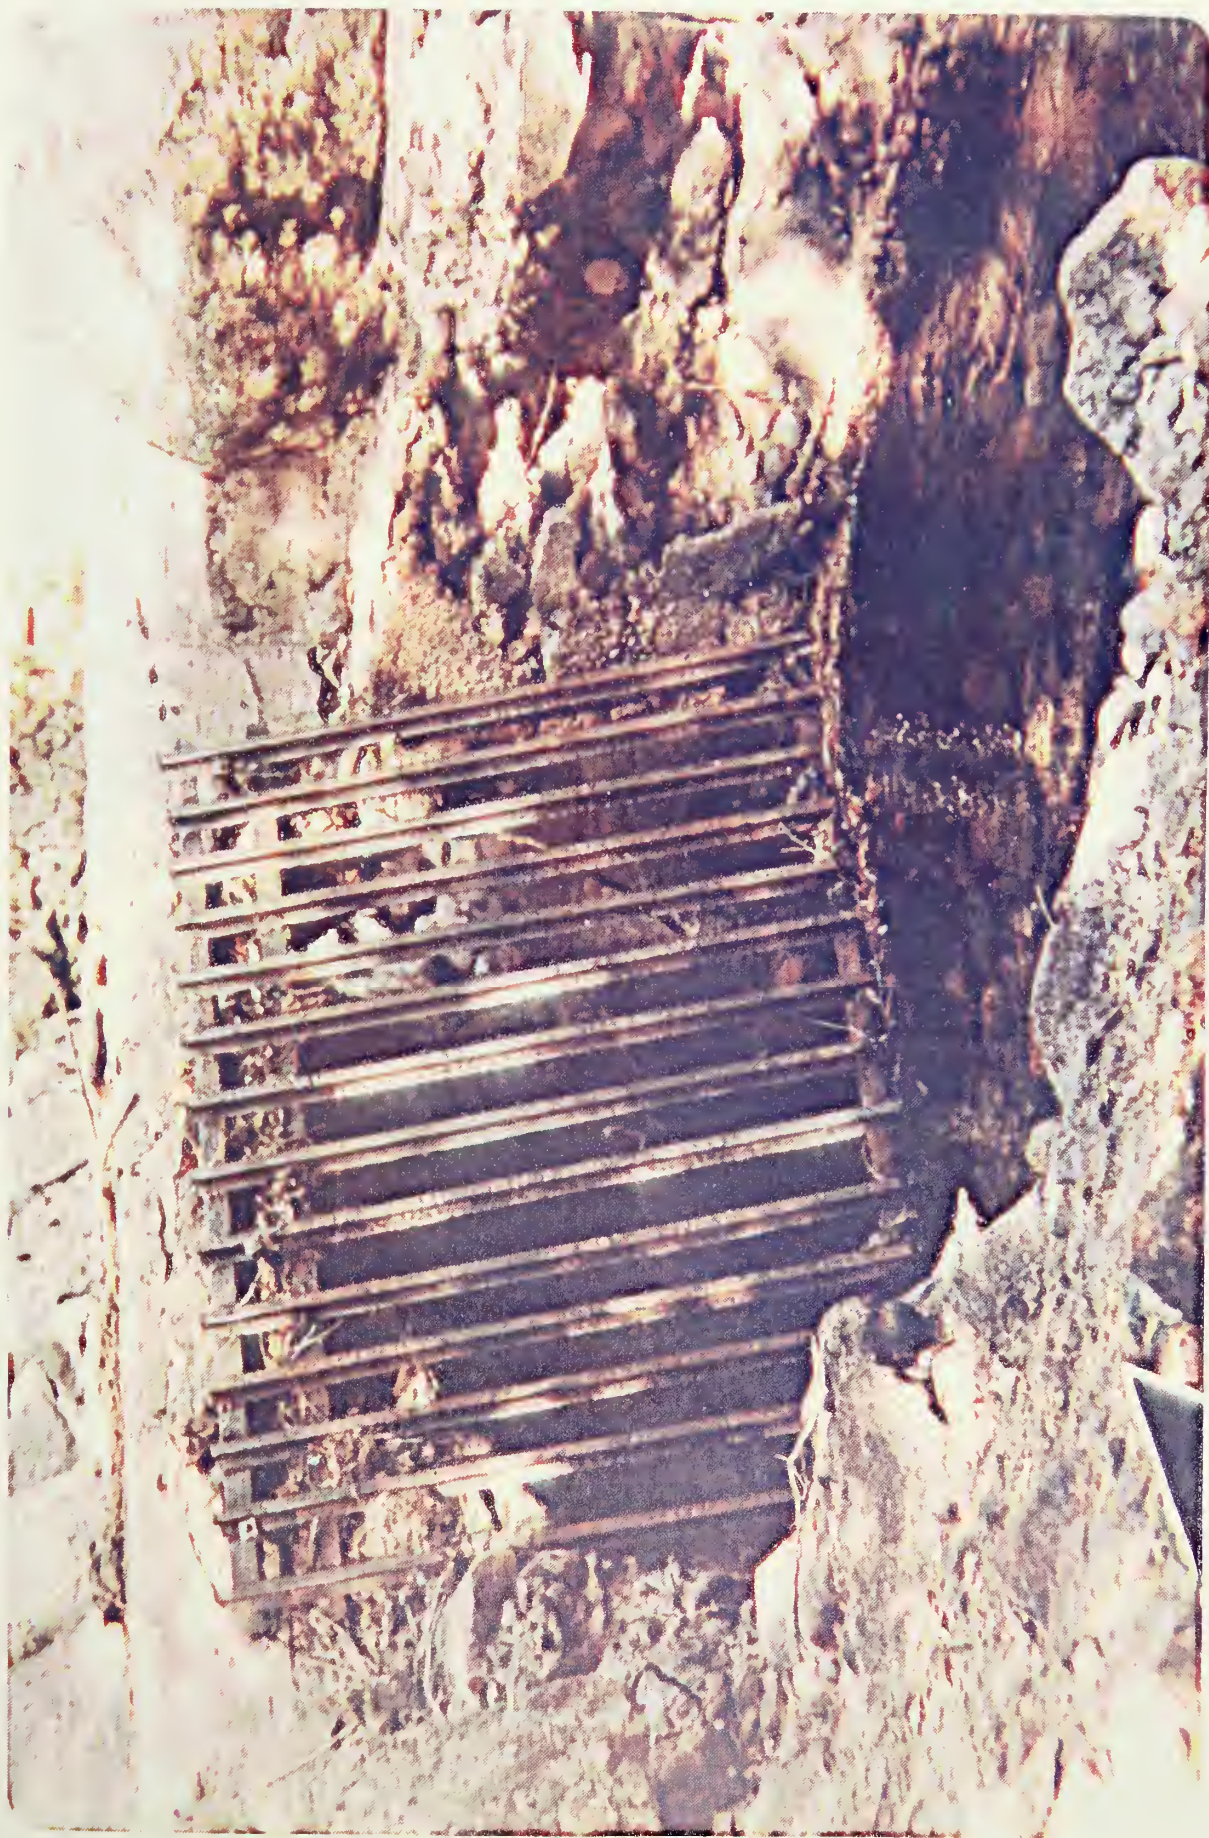
Bar Screen Before Intake

During the winter season, frazil ice builds up behind and in front of the bar screen and grid plate, preventing flow through them. When this condition is allowed to persist, a portion of the 16-inch line feeding the sedimentation tank becomes plugged, a condition extremely difficult to correct. When water ceases to enter the sedimentation basin due to these ice blockages, well number 1 is the only water source available to supply valley water needs. The present method of preventing these ice blockages is to daily monitor the conditions of the bar screen and grid plate and manually prevent ice buildups.

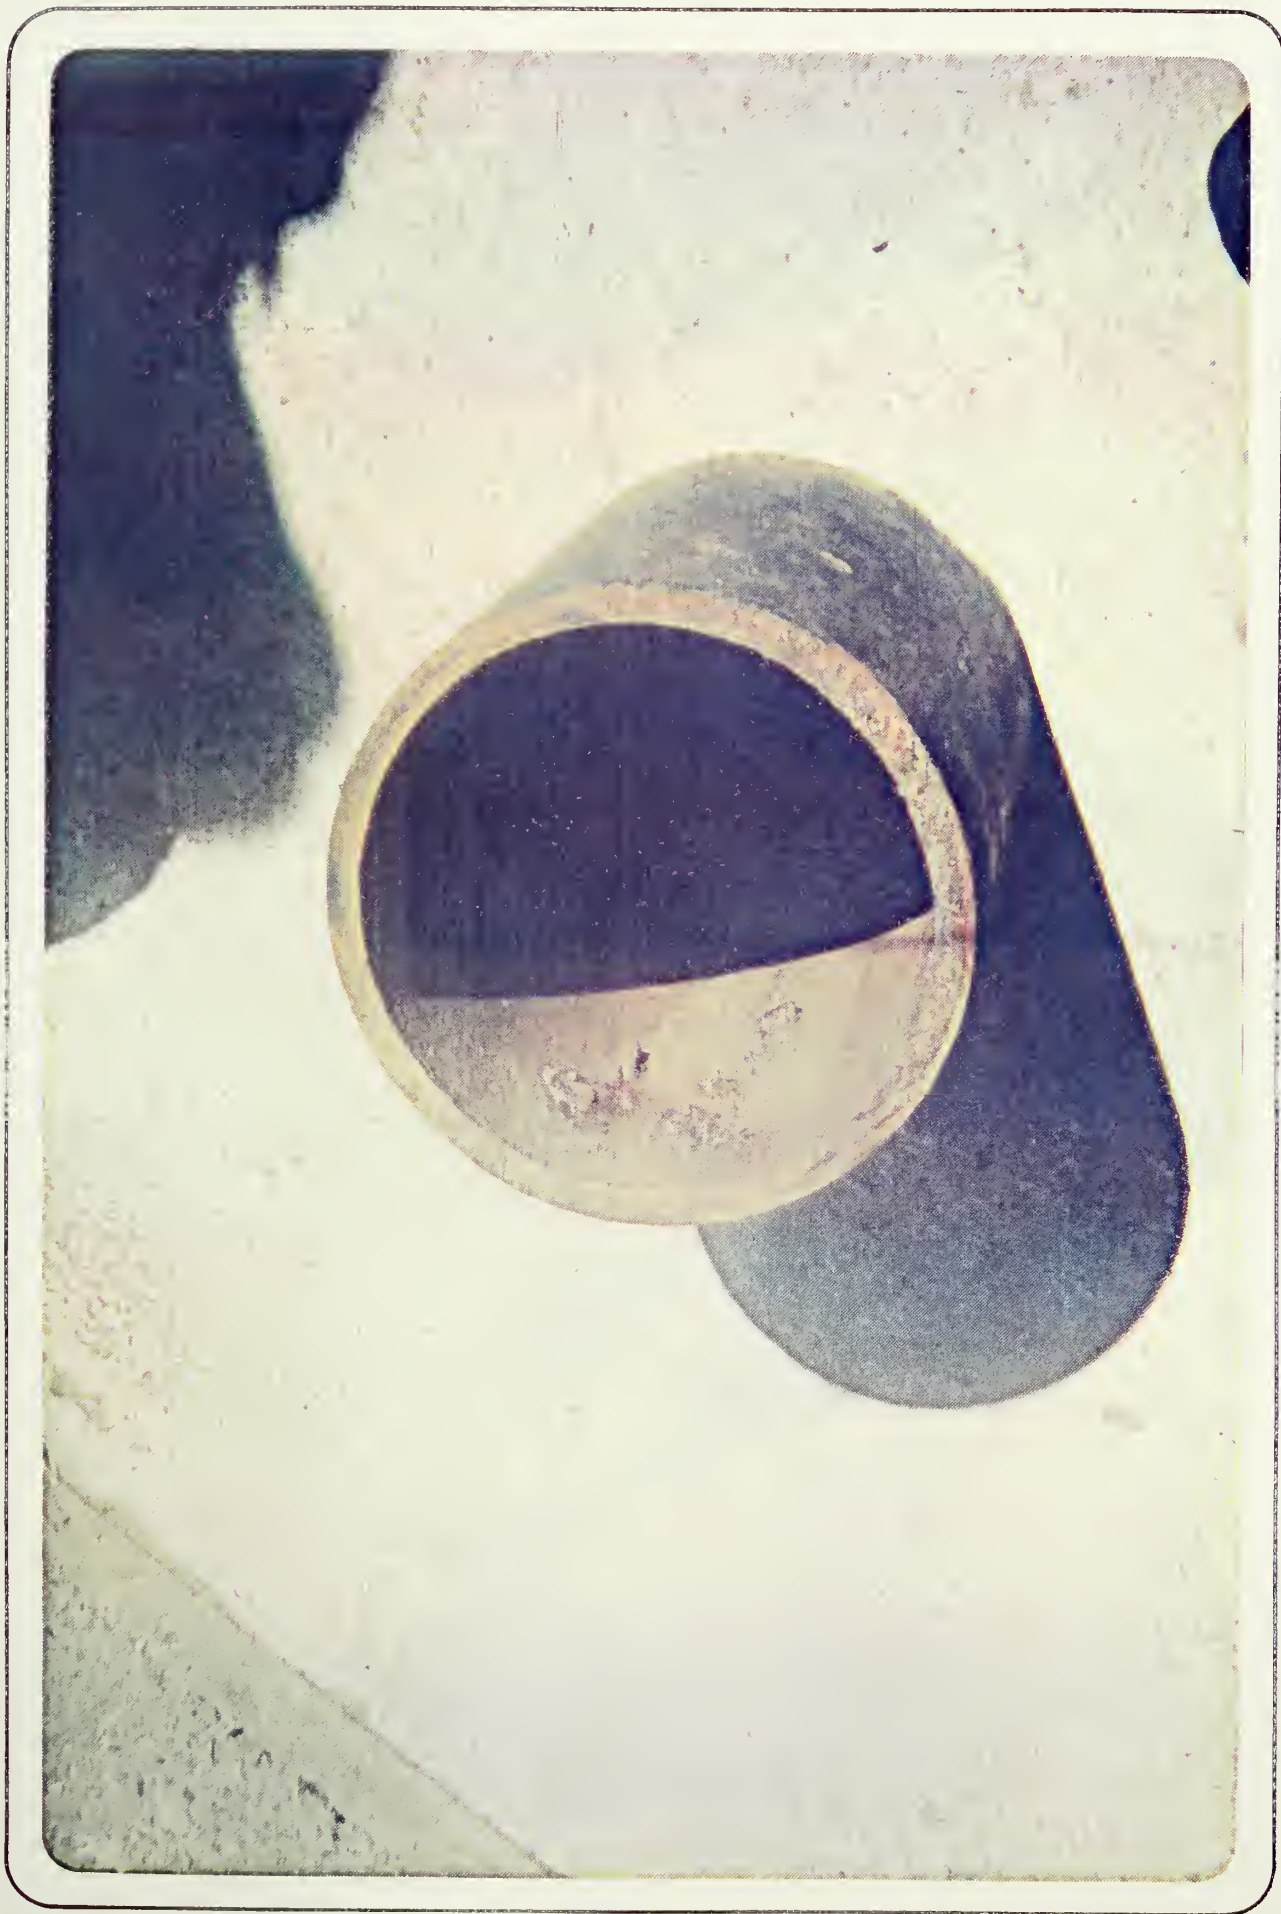
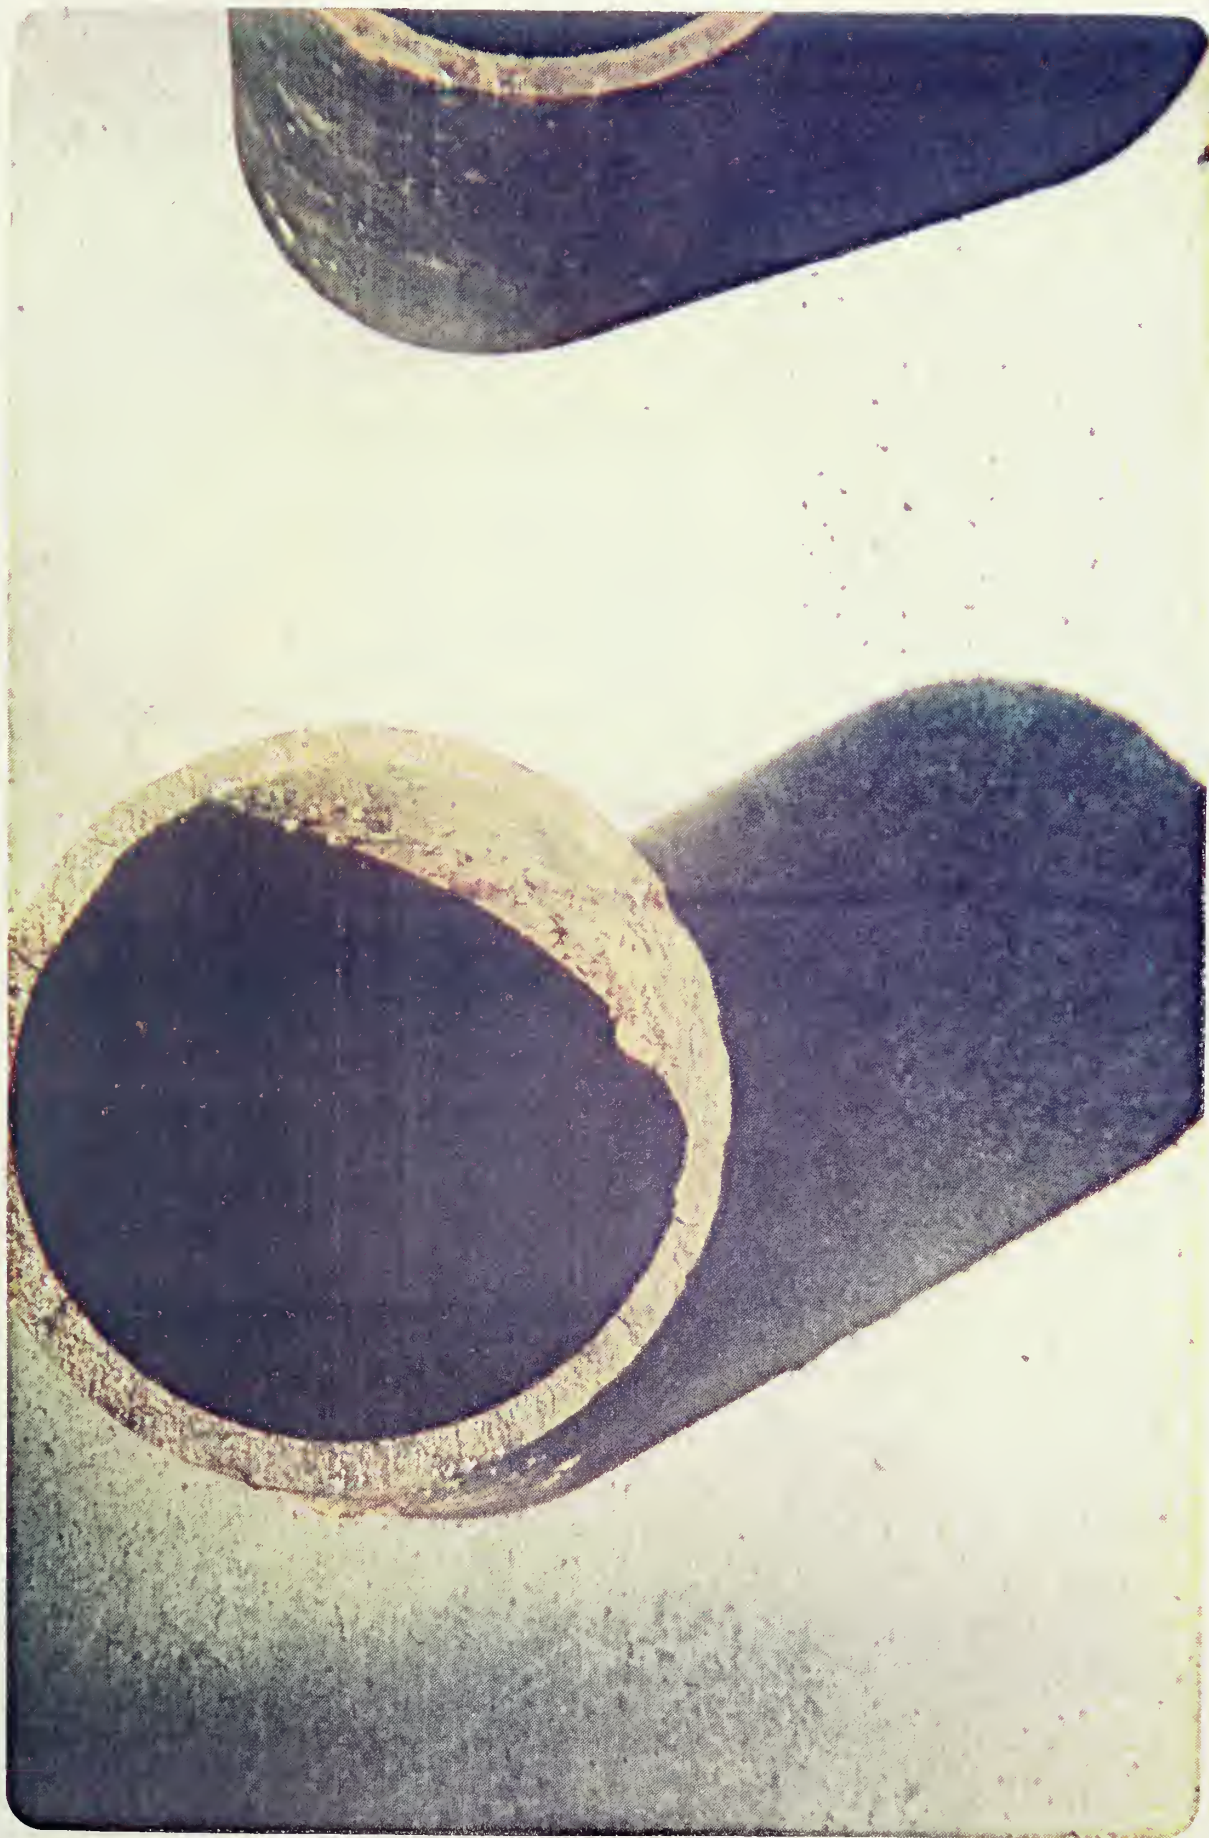
Cast Iron Pipe

Because the condition of the existing cast-iron pipe seems to be relatively good (appendix D), rehabilitation rather than replacement is recommended.

Rust deposits and tuberculation require that the cast-iron lines be cleaned and all the mains be flushed out (due to the cleaning operations and possible sand accumulations). More pipe samples are currently being taken to better analyze the existing pipe conditions.
